ASHFORD BOROUGH COUNCIL

Conningbrook Lake Baseline Assessment and Rehabilitation Plan

2nd November 2016

Final Report Version 1.2

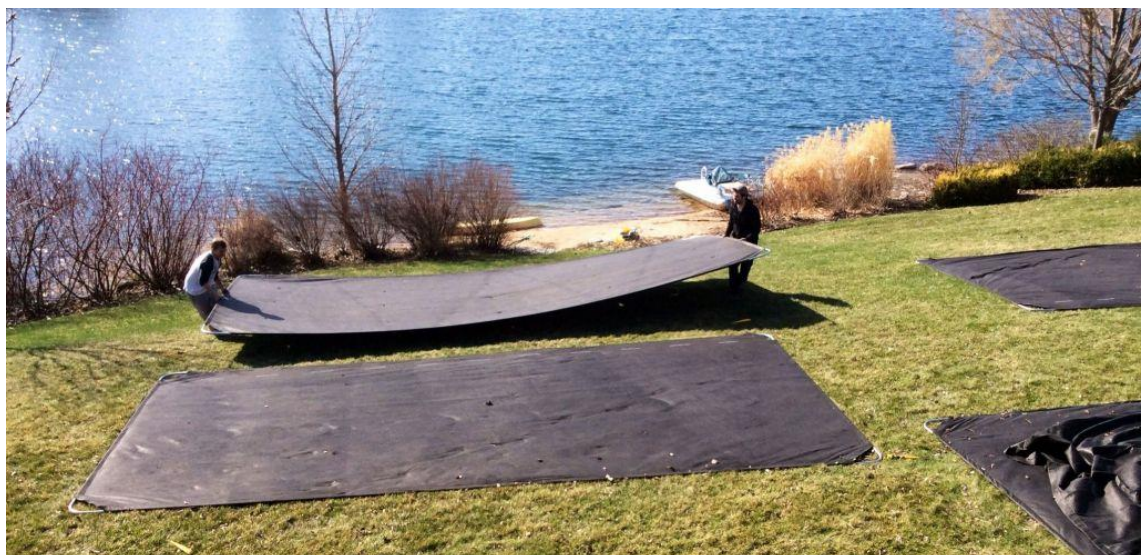
Another effective method of preventing submerged aquatic plant development is using self-sinking frame-mounted geotextile to cover areas of the lake bed.

This approach prevents plant growth by stopping light and also the chemistry changes that occur in the sediment below the cover can cause the roots of the plants to die back. This approach is commonly used in the USA to keep areas of the lake weed free. It is recommended that a lake mat is deployed in front of access and egress points of the western bank of the Main lake to maintain submerged plant free areas. These mats are available commercially in the USA and sold as 'Lake Mat-Pro™'. Another type of mat is also available which is sold as a Muck-Mat™. This is similar to a lake mat but is reinforced with an underlying geogrid and design to prevent lake users from sinking into lake silt. This may provide a more robust solution if there is expected to be a lot of user traffic at access and egress points.

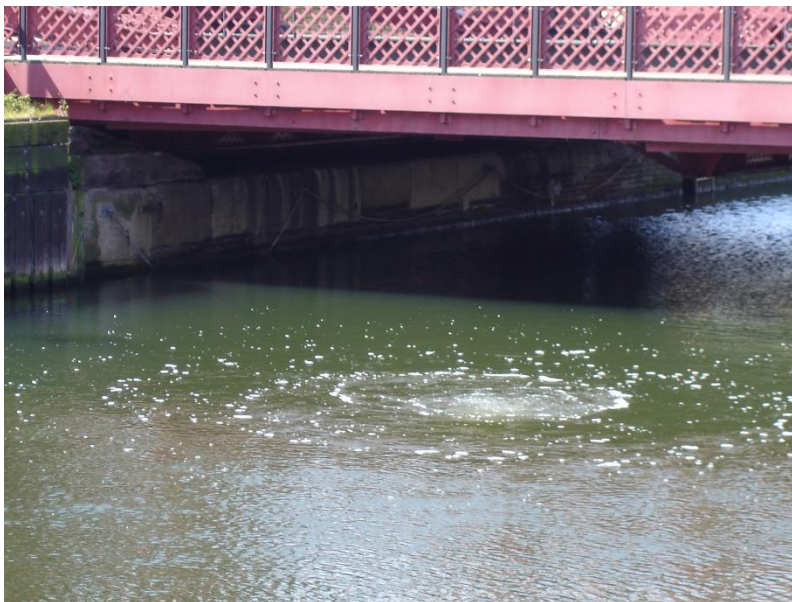
On amenity lakes, the approach for mixing is to usually use an array of fine bubble diffusers across the lake bed which are supplied with compressed air through self-sinking airlines from a bankside compressor station. Therefore, all the equipment on this type of system sits on the lake bed and prevents no interference to either boating or angling activities. The systems are robust with a low maintenance requirement but do have an operational cost in terms of electricity supply and on-going periodic maintenance. The use of propeller mixers are generally avoided on activity lakes due to the potential health and safety risks. Diffuser based systems operate by creating columns of air rising from the diffusers to the lake surface which act as air lifts drawing poor quality water from the bed and exposing it to the atmosphere where it is oxygenated. Circulations cells develop around each diffuser which is known as primary mixing sphere and is a function of water depth. The primary mixing cell is a radial distance of 5 to 7 times the water so deeper waterbodies require less diffusers to mix the waterbody. Secondary circulation currents develop between the primary mixing areas such that the entire water is mixed.

The appearance of an operating diffuser is shown in the following photograph.

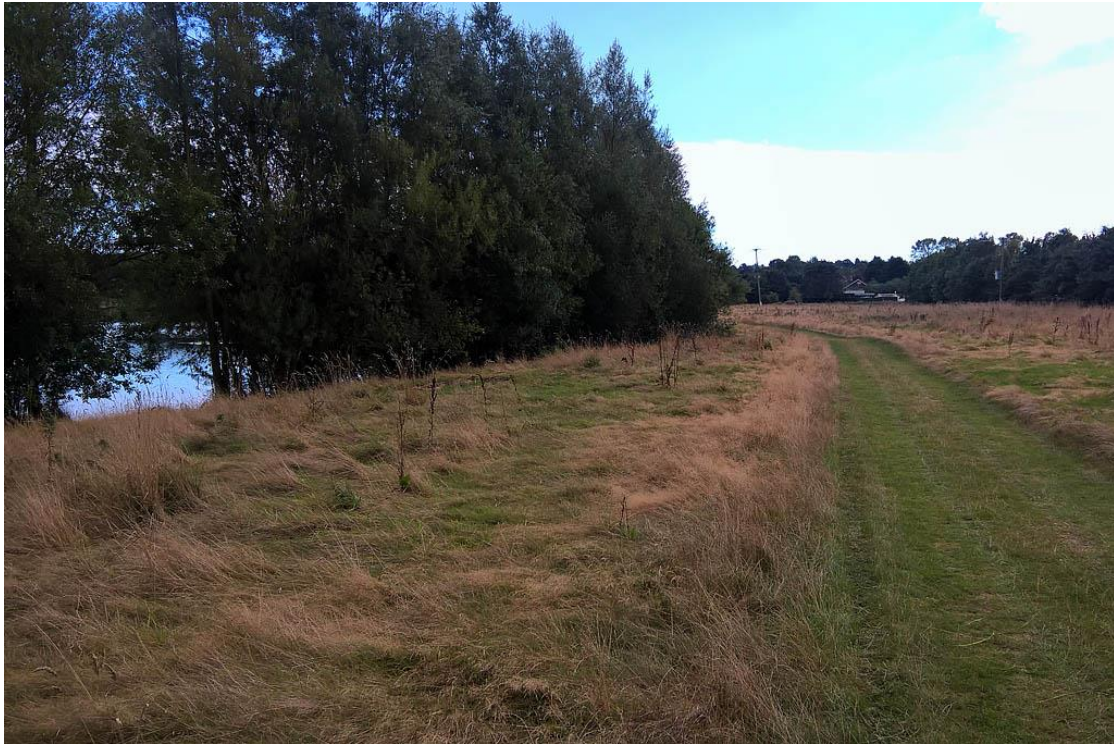
Photograph 3: Mown informal access footpath in south-west corner of the main lake.

Public footpath access is only available at present around south-western, southern and eastern banks of the main lake. The northern and north-west banks currently have no public access due to on-going quarrying activities in this area. Footpaths are informal and comprise of mown strips through the rough grassland areas that surrounds the lake in these public access areas (see Photograph 3 in Appendix A).

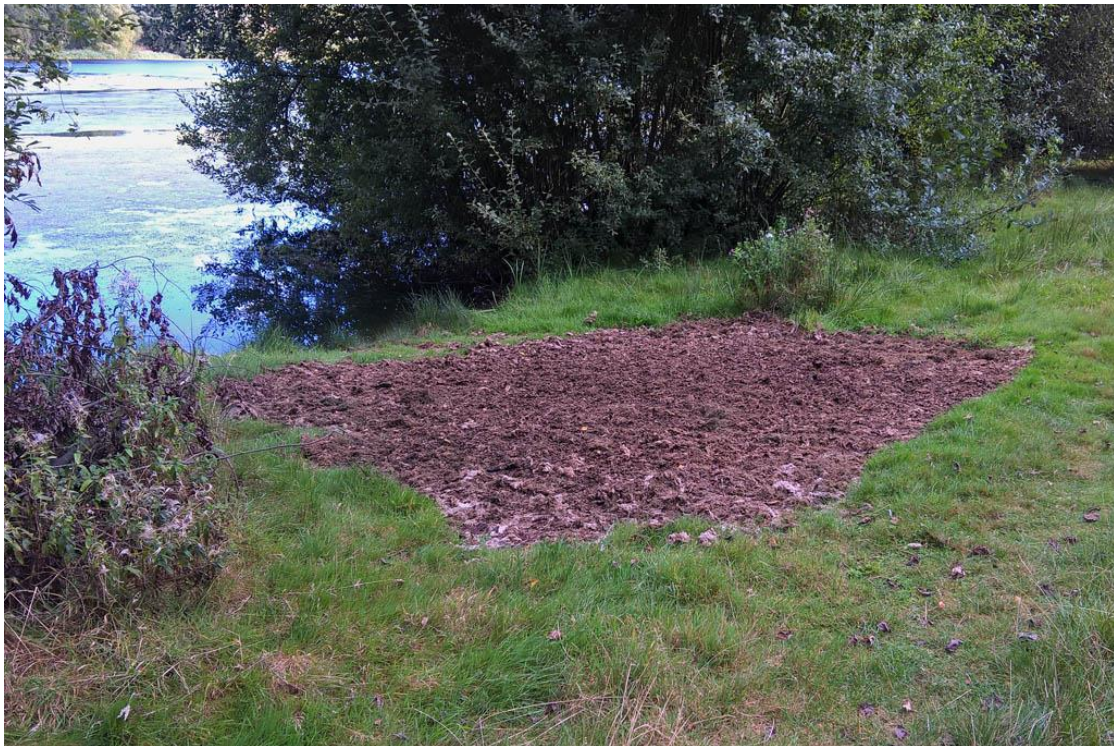
Photograph 4: Angling peg showing decomposing cut aquatic plant deposits.

All removed plant material should be disposed of at distance from the lake and it is recommended that it is ideally taken to a local authority composting facility if available.

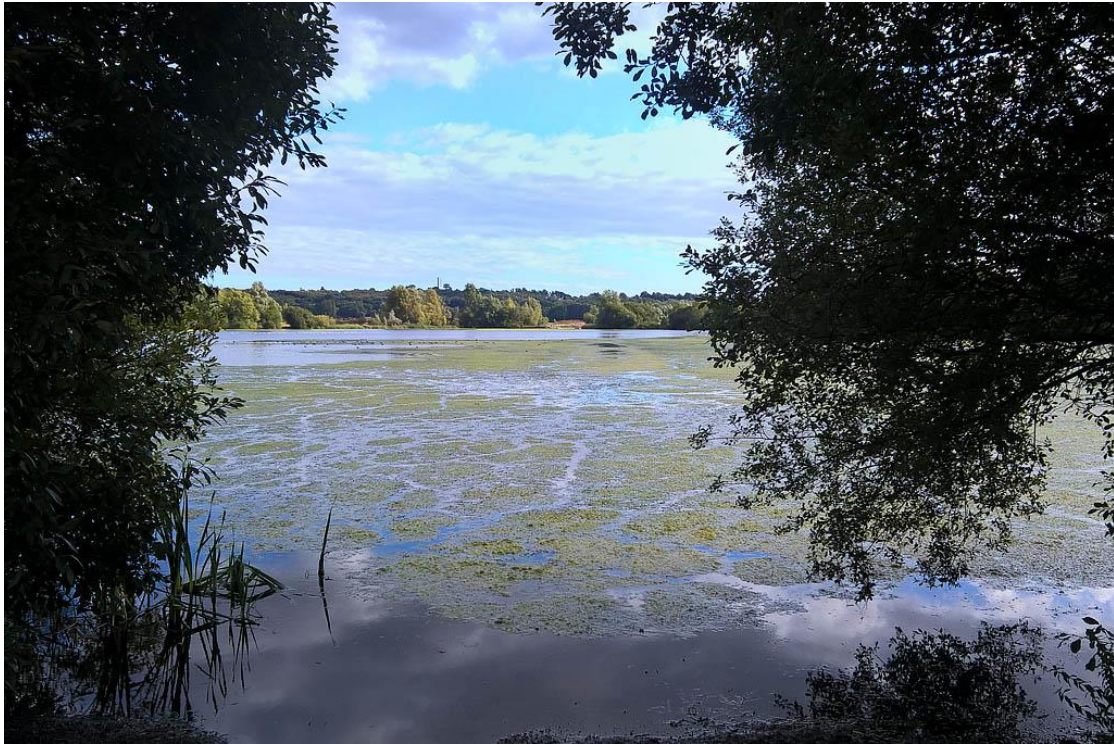
Access to the water edge is generally restricted to informal fishing pegs located at various points around the lake and comprise of mown areas with accompanying thinning of bankside trees. It was noted that fishing pegs had been used for depositing aquatic plants from previous cutting works and the plant material had been left to decompose on the lake bank. (See Photograph 4 in Appendix A). It was further noted that the trees located adjacent to some of the fishing positions were overgrown in places and require some pruning to facilitate ease of angling activities (see Photograph 5 in Appendix A).

Photograph 5: Angling peg showing bankside trees requiring some pruning.

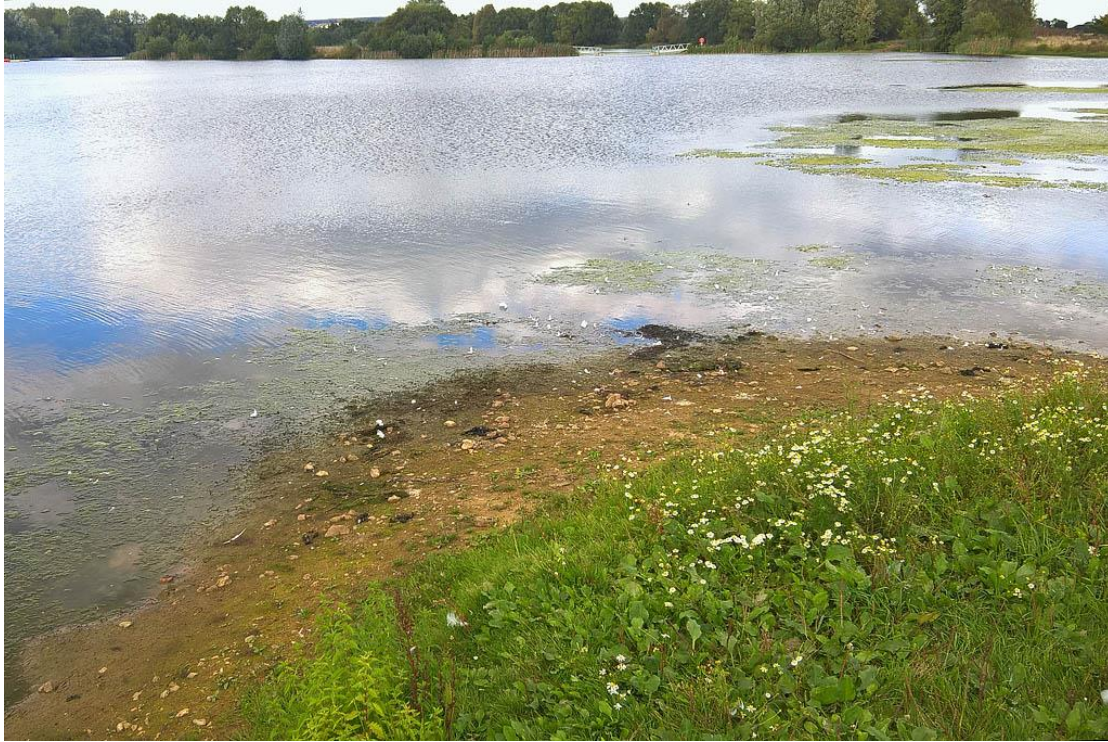
A gravel access area to the lake has been constructed on the western bank. This has been placed to aid and provide safe exit point from the lake for competitors in triathlon events (see Photograph 6 in Appendix A). There was little evidence of bank erosion around the lake margins which are well consolidated with established terrestrial and semi-aquatic marginal vegetation. The only area where some bank erosion was noted was on the small peninsula on the southern bank where grazing livestock visit the lake to drink (see Photograph 7 in Appendix A).

Photograph 7: Eroded area on the southern bank due to livestock.

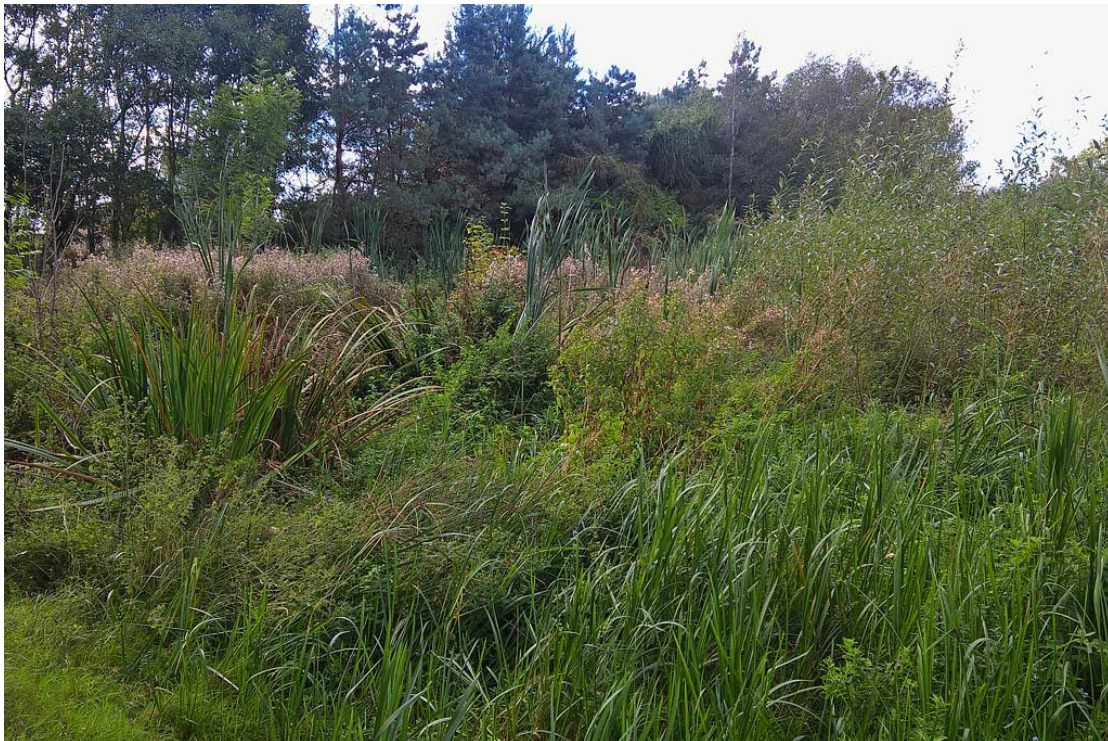
Photograph 8: Vegetated ditch drainage channel in the north-west corner of the main lake.

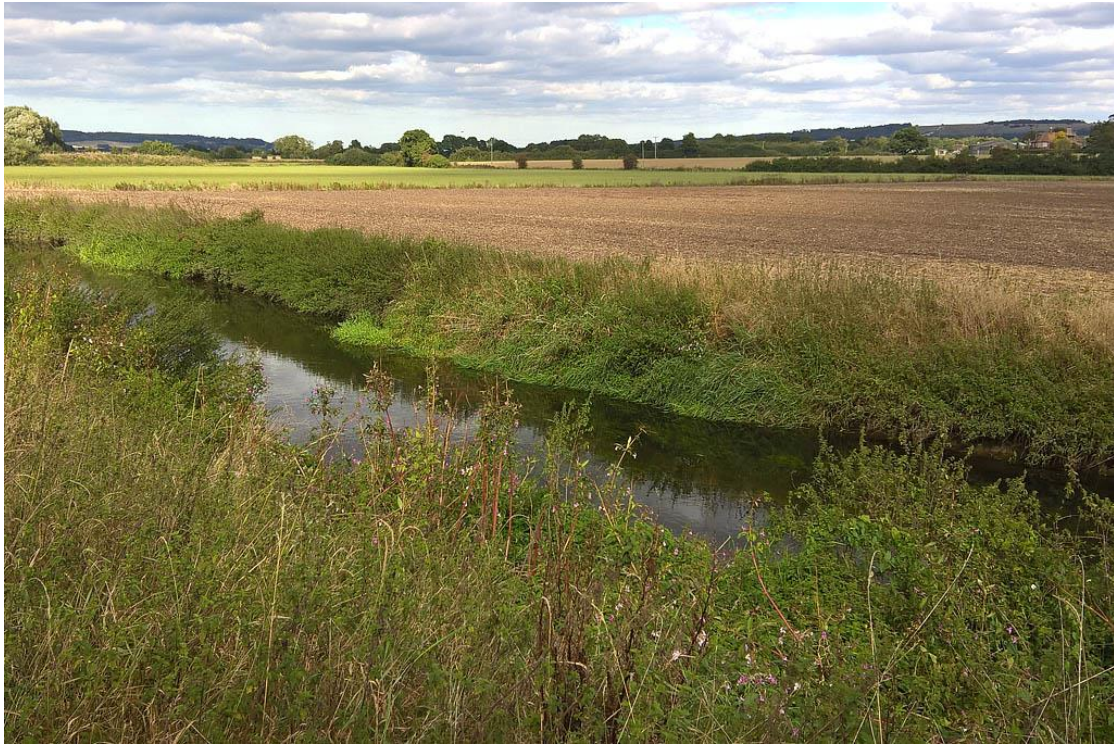
Photograph 9: Great Stour along the eastern bank of the Main Lake.

The Great Stour flows parallel to the south and eastern bank of the main lake. The river channel appears that it has been subject to historical engineering works in these areas resulting in a straightening and uniformity of the channel. The water level in the river appeared to be approximately 1.5m below the level in the lake at the time of the visit suggesting that hydraulic connectivity between these two surface water features is very limited (see Photograph 9 in Appendix A).

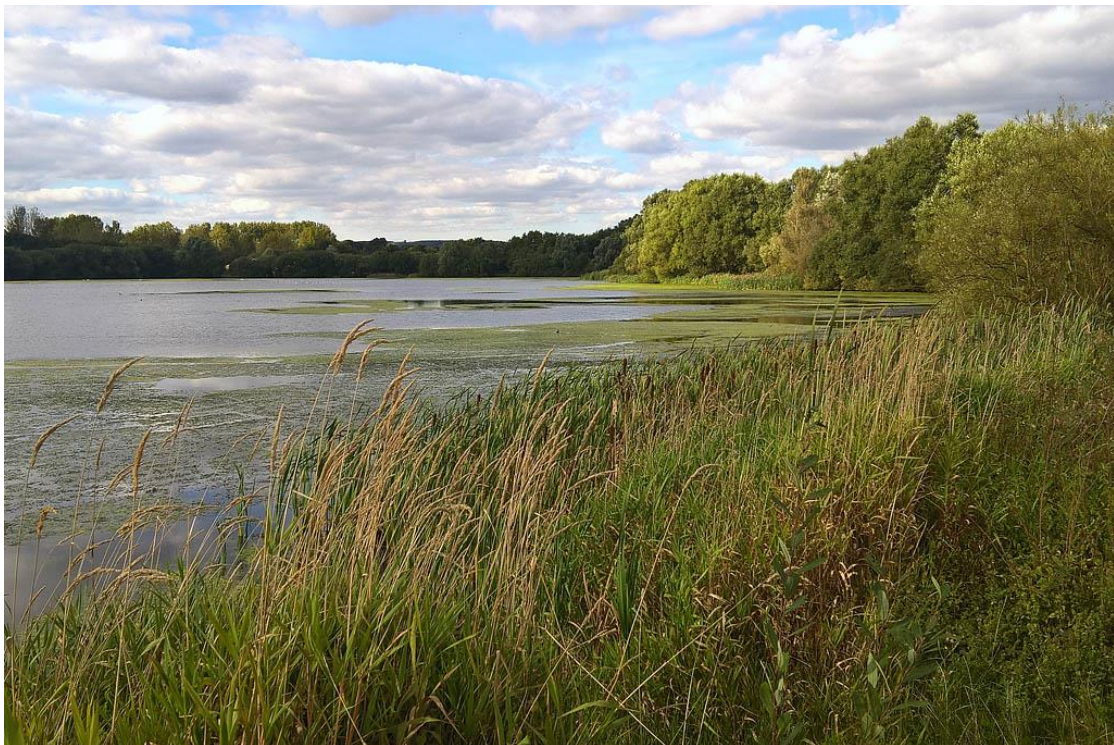
Photograph 10: View to northern end of the Main Lake showing established bankside trees.

The lake surrounds consist of rough grassland areas that are managed through grazing by sheep and cattle to enhance ecological biodiversity. Established bankside trees, together with scrub, are present around most of the northern area of the lake and in the south-western corner (see Photograph 10 in Appendix A). The south-east corner of the lake has fewer trees and a more open aspect. The stands of trees are dominated by a variety of willow species (*Salix* sp.) and Alder (*Alnus* sp.)

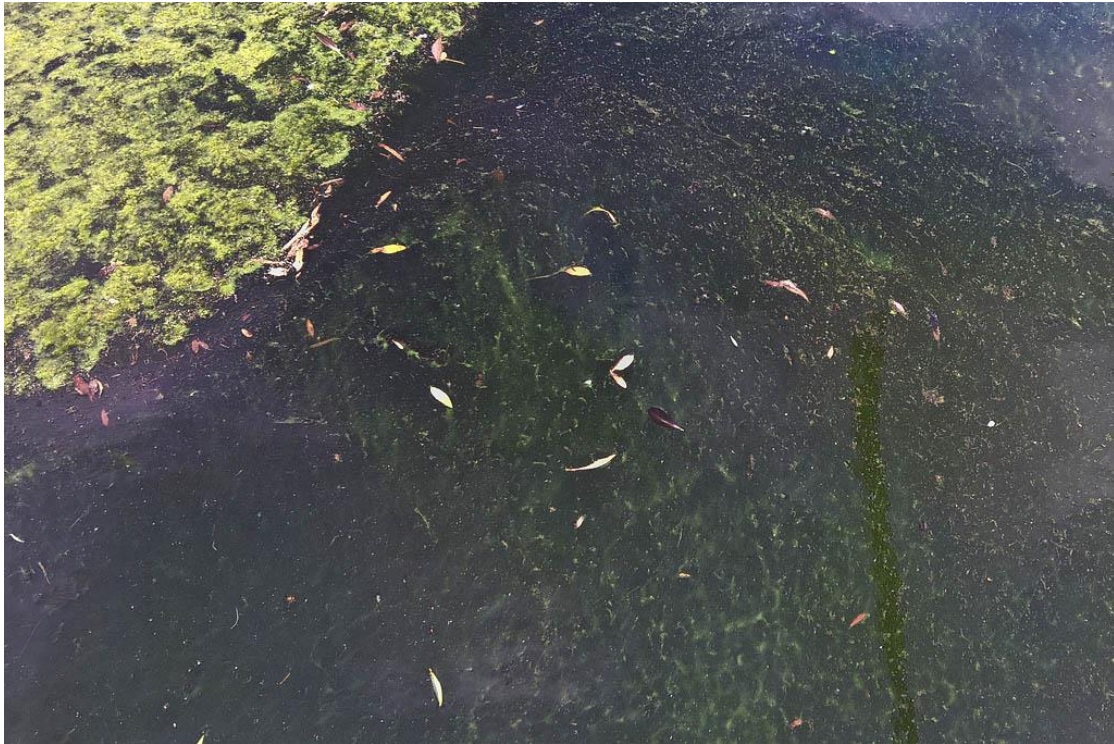
In terms of the recreational use of the lake, the key consideration is the presence of blue-green algae that can form potentially harmful toxic scums. *Microcystis* is noted as toxic and scum forming species. Scums of *Microcystis* were observed in some of the marginal areas and had also accumulated in filamentous algae which had developed on the surface growth of Canadian Pondweed. *Microcystis* density ranged from 1786 (WS4) to 6431 (WS3) cells/ml with the highest

Photograph 11: Blue-green algae and associated scum formation with filamentous algae.

It would be advantageous to maintain the submerged plants with limited surface growth, to prevent the issue observed during the site visit, of accumulations of blue-green algae becoming trapped and effectively forming a scum. Such scums would present an increase potential health risk to site users undertaking water-based activities.

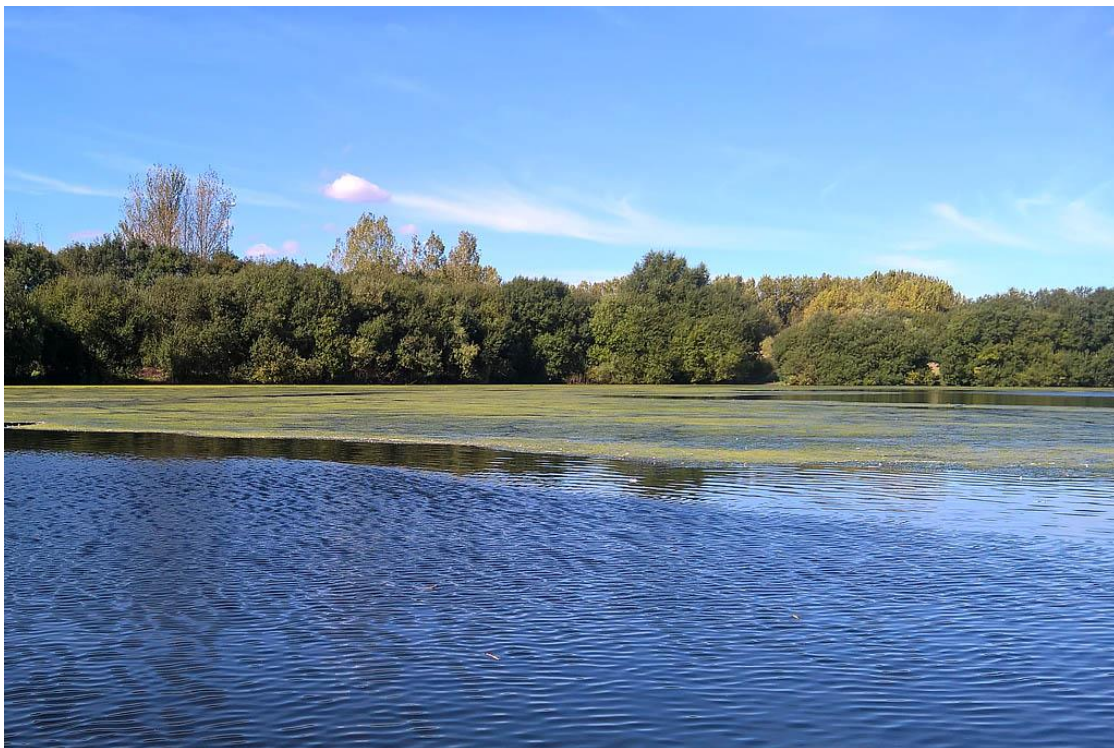
Photograph 12: Surface growth of Elodea and filamentous algae in the north-west corner of the lake.

Given the amenity use of the lake, it is recommended that submerged plant growth is allowed to develop around shallow marginal areas with the deeper central area of the lake maintained free of plants for activities to pursued. Access and egress points to the lake together with the channels in front of angling pegs should also be maintained free of submerged plants.

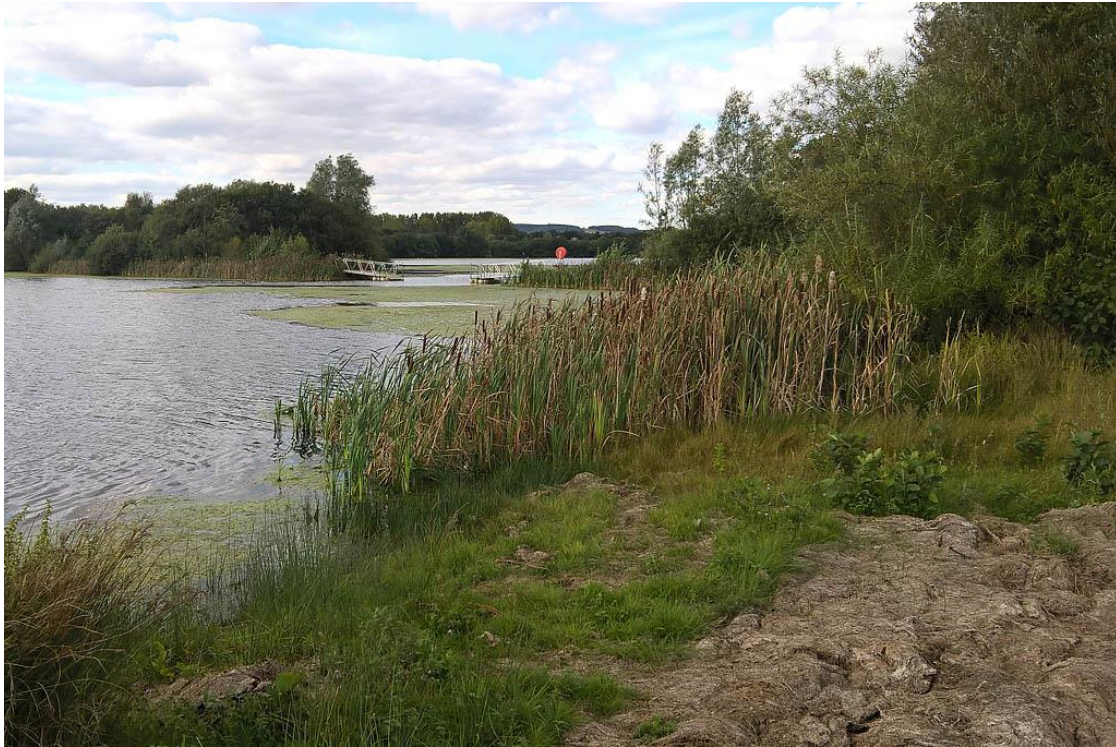
Photograph 13: Established bed of marginal Reedmace (*Typha maxima*)

Established beds of emergent aquatic plants are present in areas around the lake and island margins. These stands of emergent plants were generally more established within the older northern part of the lake. The development of these beds was typically limited to a narrow vegetated fringe of up to 5m in width. This will be a result of the apparent relatively steep gradient of the lake margins limiting the availability of suitable shallow water depths. The diversity of marginal species was relatively moderate with the dominant species being Reedmace (*Typha maxima*) (see Photograph 13 in Appendix A). Other species present include Reed Canary Grass (*Phalaris arundinacea*), Common Spike Rush (*Eleocharis palustre*), Soft Rush (*Juncus effusus*), Hard Rush (*Juncus inflexus*), Water Mint (*Mentha aquatica*), Yellow flag (*Iris pseudocorus*) and Water Plantain (*Alisma plantago-aquatica*). The latter is shown in Photograph 14 in Appendix A. Some of these plants are only present with limited abundance and distribution around the lake.

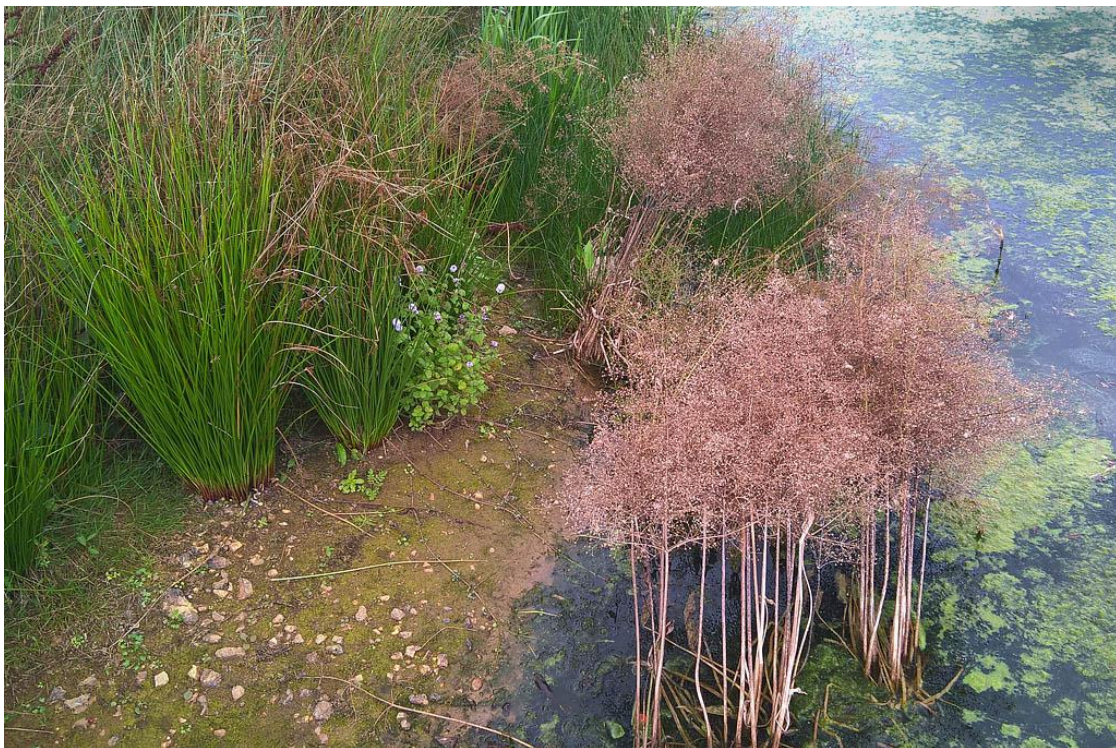
Photograph 14: Hard Rush, Water Mint and Water Plantain on the western bank.
