ASHFORD JOINT TRANSPORTATION BOARD
8 MARCH 2011

Subject:	Ashford Pedestrian Guardrailing Assessment
Director/Head of Service:	Director of Kent Highway Services
Decision Issues:	These matters are within the authority of the Kent County Council
Decision:	Non-key
CCC Ward/KCC Division:	Bockhanger, Godinton, Stour and Victoria
Summary:	<i>The Board is asked to consider and comment on the proposals to manage sections of guard railing in Ashford</i>
To Note	The proposals as identified in the attached report and suggest changes or amendments
Classification:	THIS REPORT IS OPEN TO THE PUBLIC

Kent Pedestrian Guard Railing Assessment

Ashford – Post Consultation Report

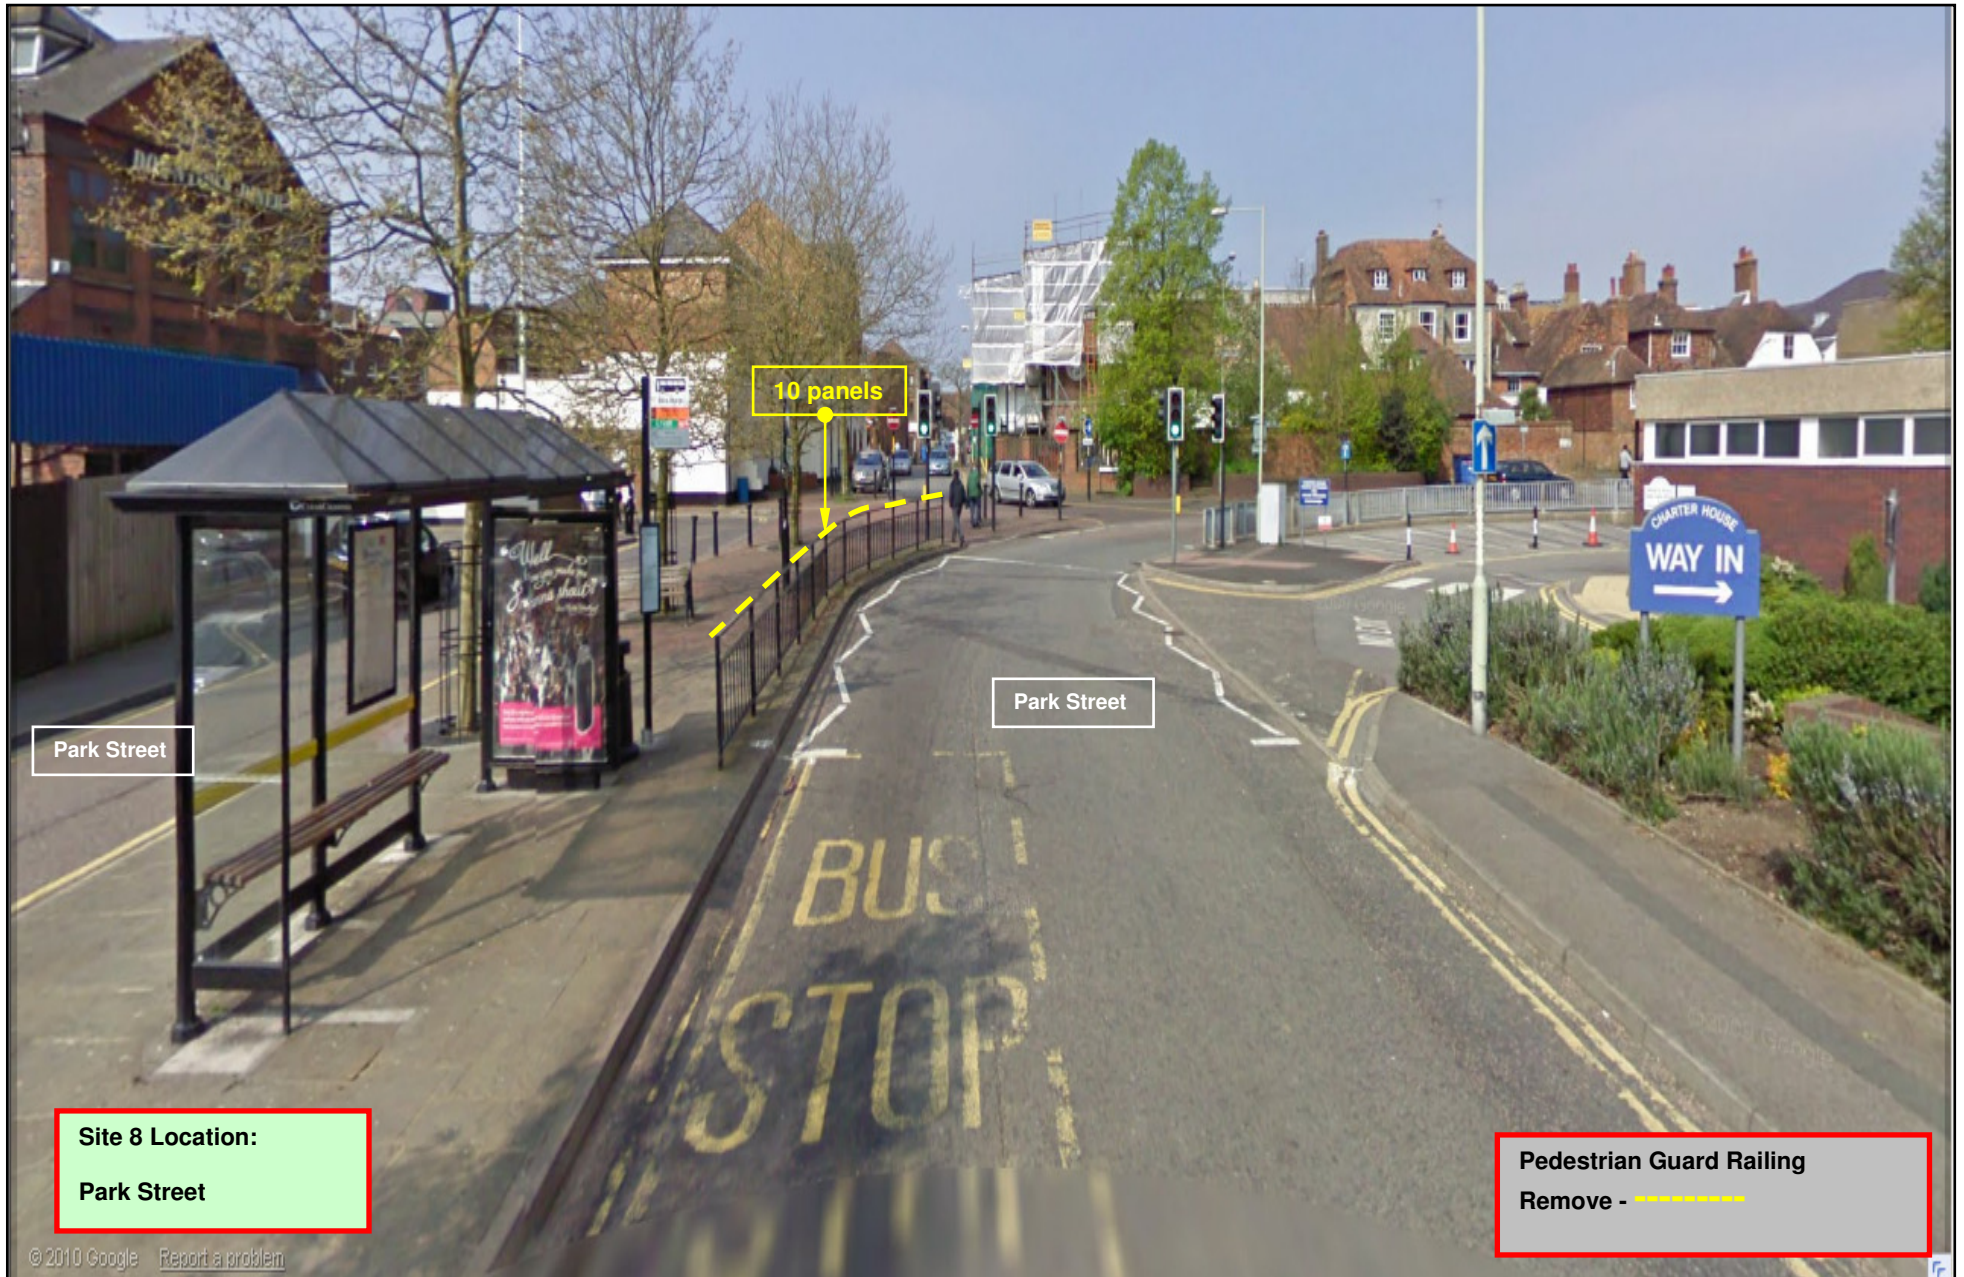
Illustrated Diagram of site 8

Site 8 is located on Park Street.

Park Street is a way one system where at the site is separated into a northern and southern section by a long central island. On the northern side of the central island are bus stops and the southern part of Park Street is an access and egress for taxis, a restaurant and the British Heart Foundation.

The pedestrian guard railing offers little benefit as a guide or protective device.

The site has both moderate volume of vehicular movement and pedestrian use.

- **It is recommended to remove the pedestrian guard railing at site 8.**

Pedestrian Guard Railing
Remove - - - - -
